Fast Facts: I-35 Rock slide

Date: June 18th 2015

Location: I-35 north bound lanes near mile marker 50

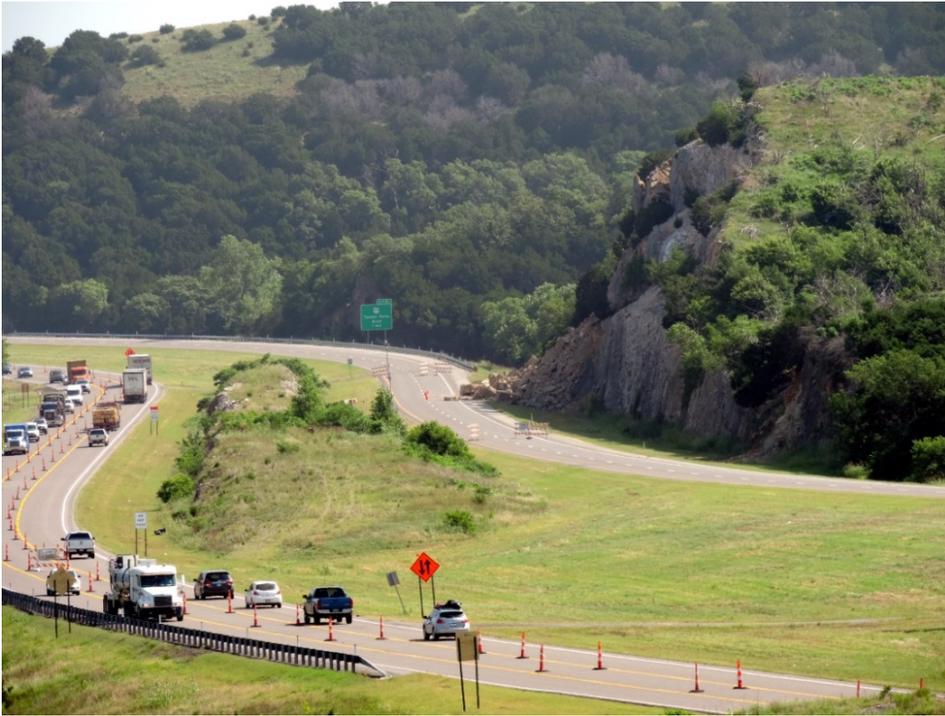
Rock slide debris pre-ODOT blasting and clean-up. The rock slide occurred on the northern end of a hill that extends along the east side of north-bound I-35 at approximately mile marker 50.

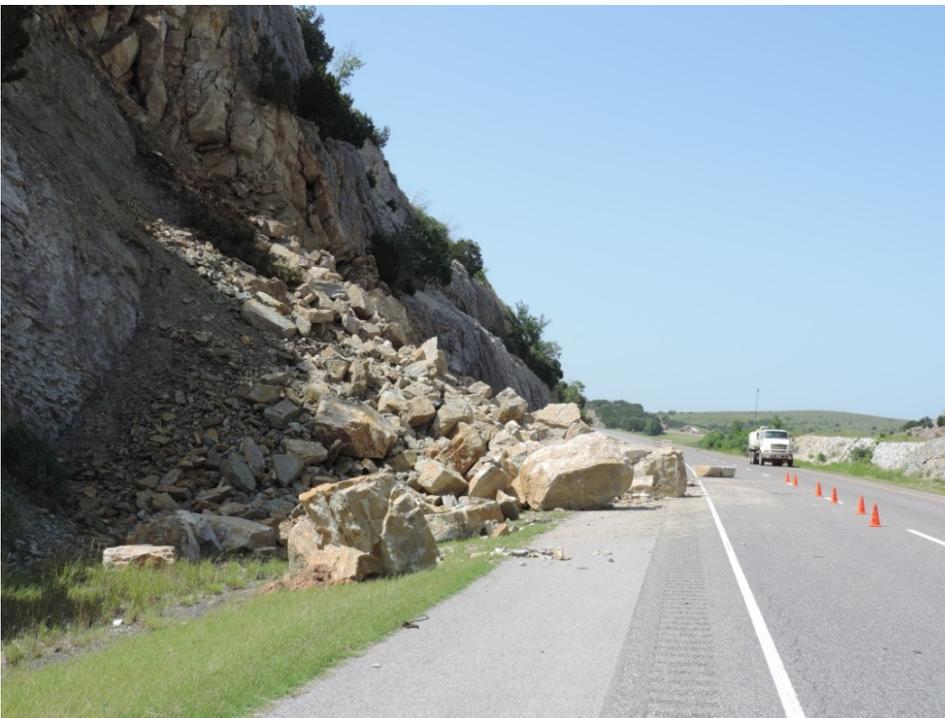
Rock slide debris pre-ODOT blasting and clean-up. Historic rainfall in 2015 is considered to be a major cause for this event. Mesonet data reported 6.5 to 7 inches of rain fell on June 17th and 18th, mainly the result of the remnants of Tropical Storm Bill.

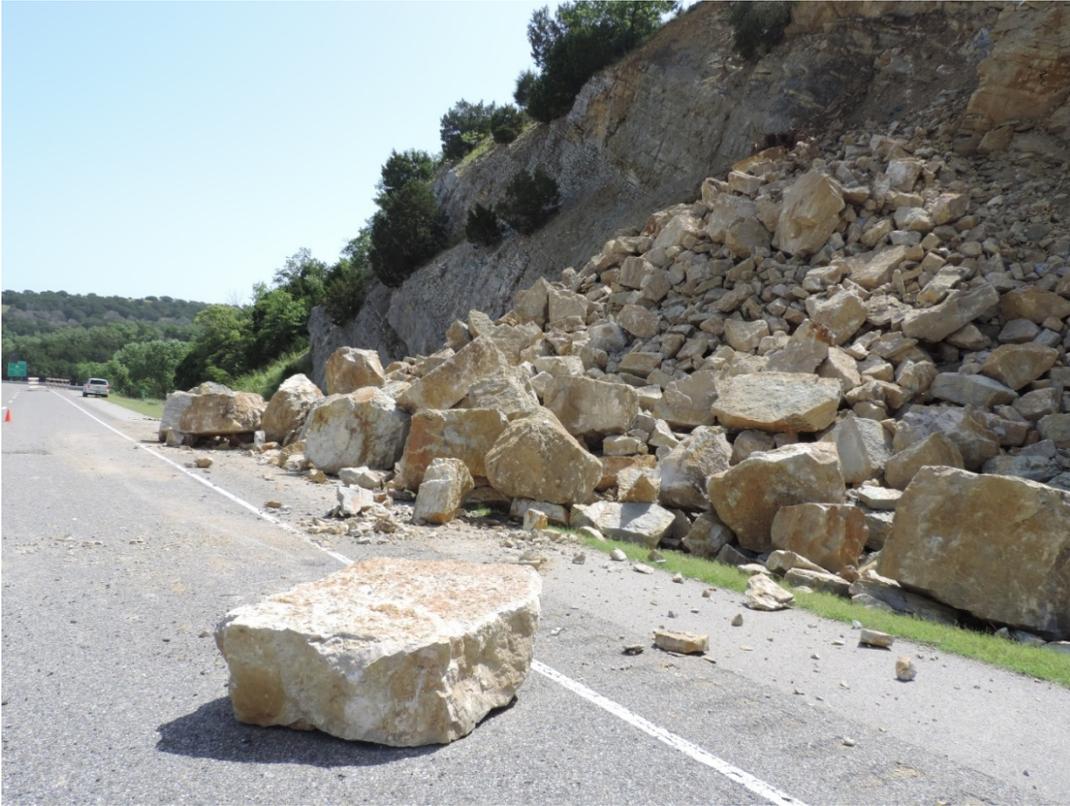
Rock slide debris pre-ODOT blasting and clean-up. The strata in this area strike in a northwesterly direction and dip approximately 30° to the southwest. Inclined rock layers and the ledges they produce are more prone to falling than layers that are near vertical.

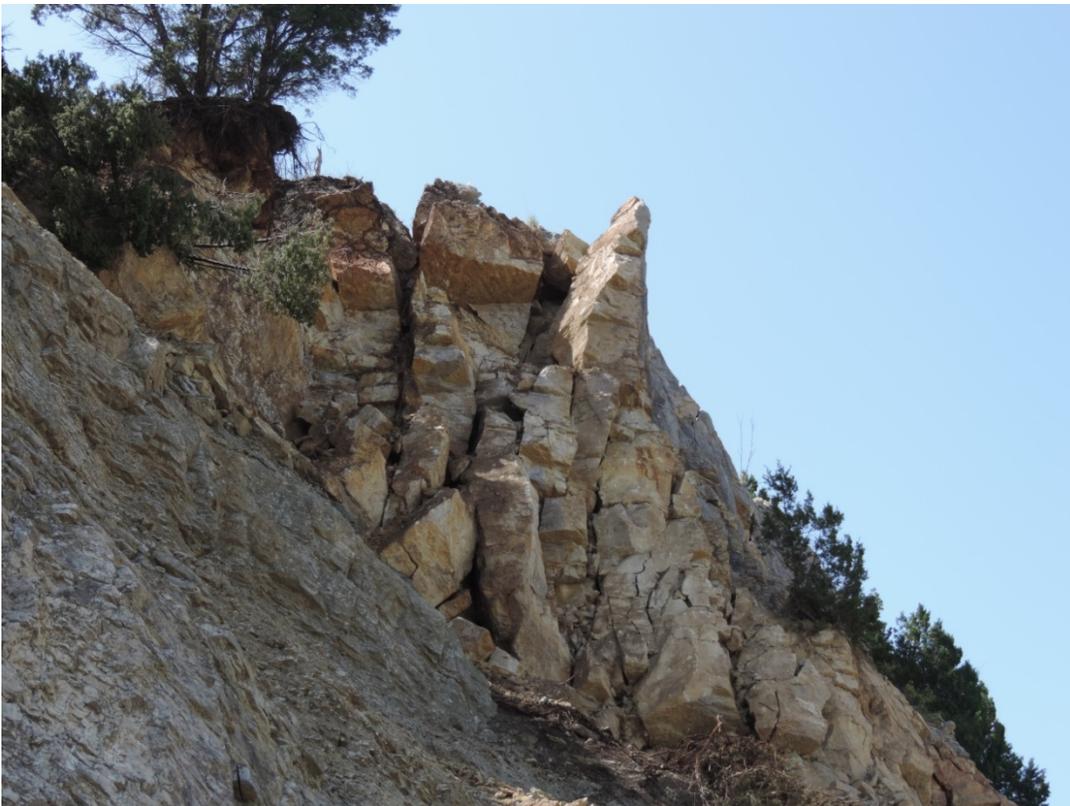
Top of roadcut pre-ODOT blasting and clean-up. This ledge near the top of the roadcut began to shift precariously after the initial rock slide. This was greatly accentuated by recent rainfall, and the original slope angle of the roadcut. ODOT used explosives in an effort to remove loose rocks, like those seen here.

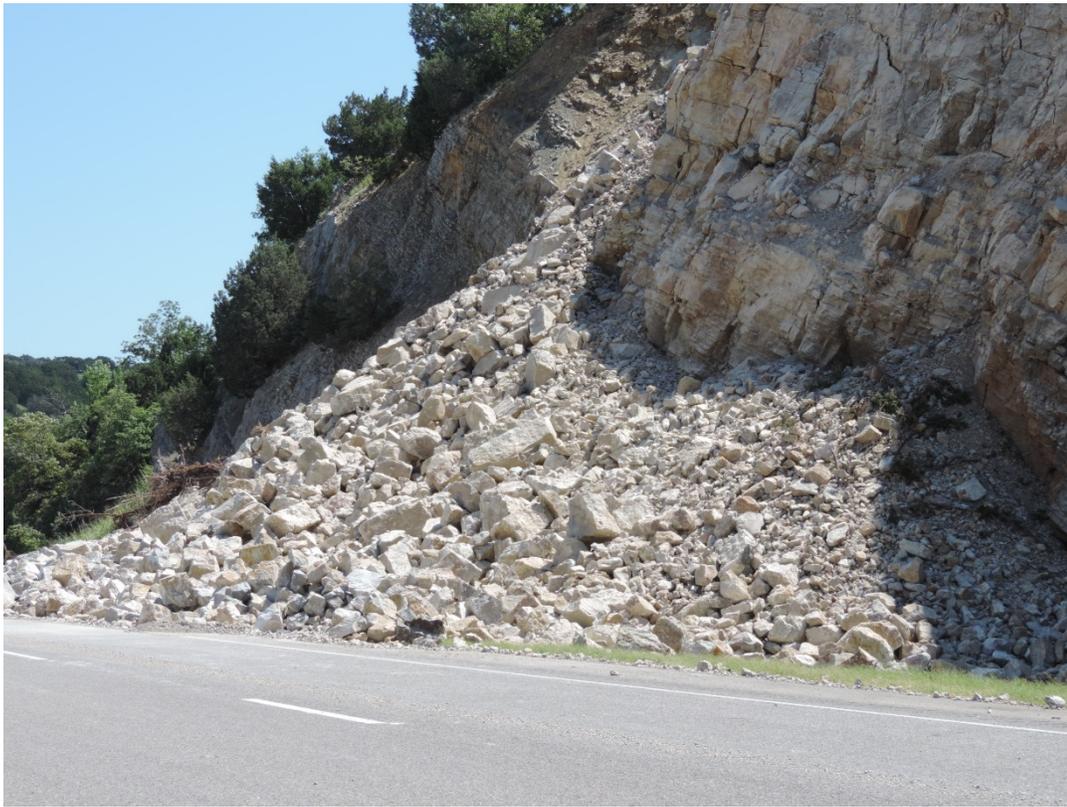
Rock slide debris post- ODOT blasting. This particular section of rocks is in the Ordovician Pooleville and Mountain Lake Members of the upper Bromide Formation of the Simpson Group. It is comprised primarily of limestone with some shale beds and echinoderm fossils.

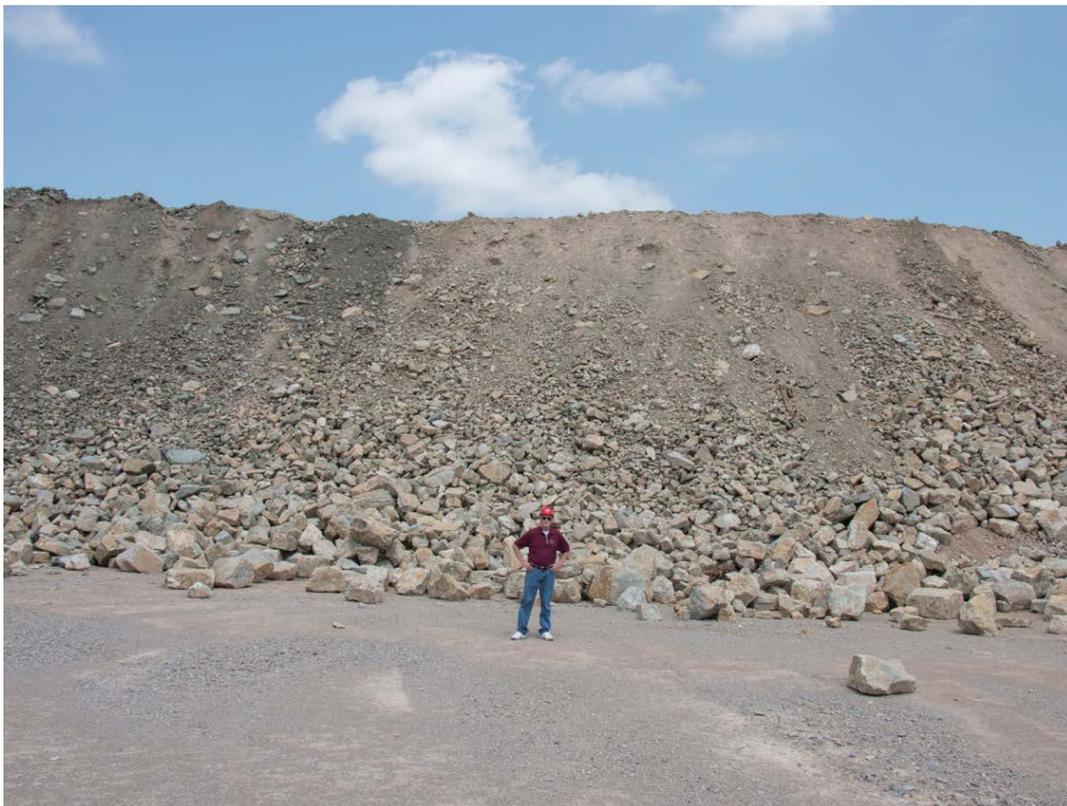
Rock slide debris pile at the Dolese quarry. About 13,000 tons of rock fell total, including the initial rock slide, blasting, and clean-up efforts. The debris was transported to the Dolese quarry and rock processing facility near Davis. The debris is located across the bottom of the hill in this photo, with OGS geologist David Brown for scale.

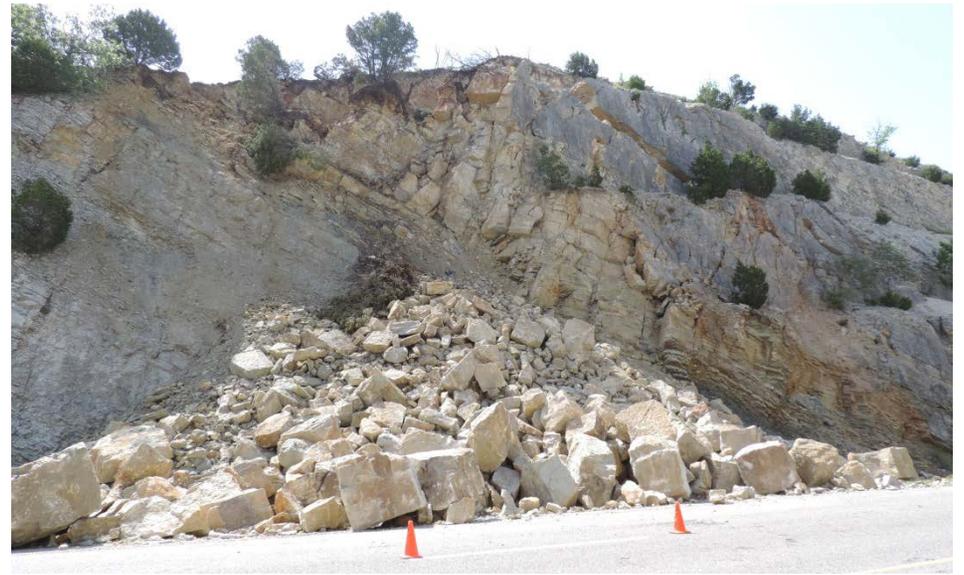
Initial rock slide debris before subsequent ODOT blasting and loose rock removal.

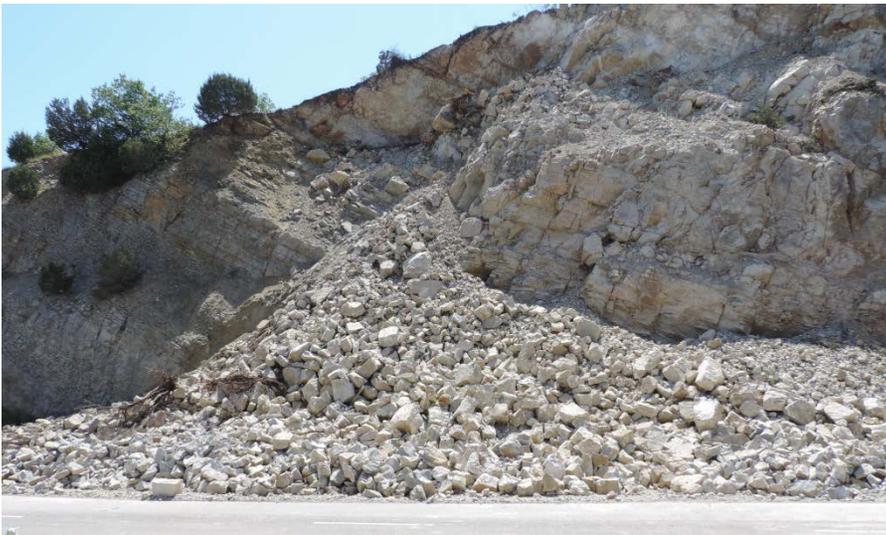
Rock slide debris after ODOT's initial blasting.

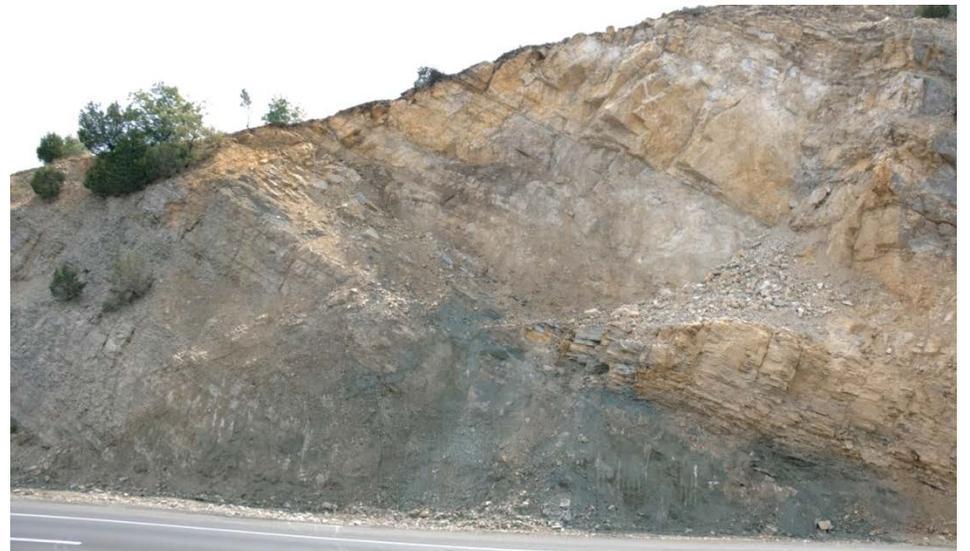
Rock slide locality after all blasting and subsequent clean-up.
