New Signs of an old Problem:

High Iron Concentrations, Corrosion of Handpump Components in Aggressive Groundwater, and Lessons From WaterAid's Recent Experiences in Uganda

Authors: **Vincent Casey** (WaterAid), **Lawrence Brown** (Hafren Water), **Jake Carpenter** (Independent) - Presenter

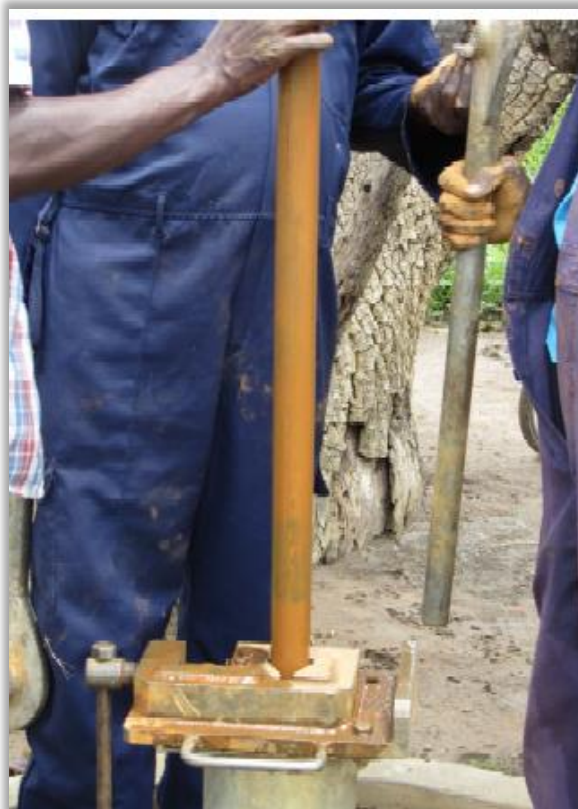
Rising Mains
(aka Riser Pipes)

Galvanized (GI) Materials:

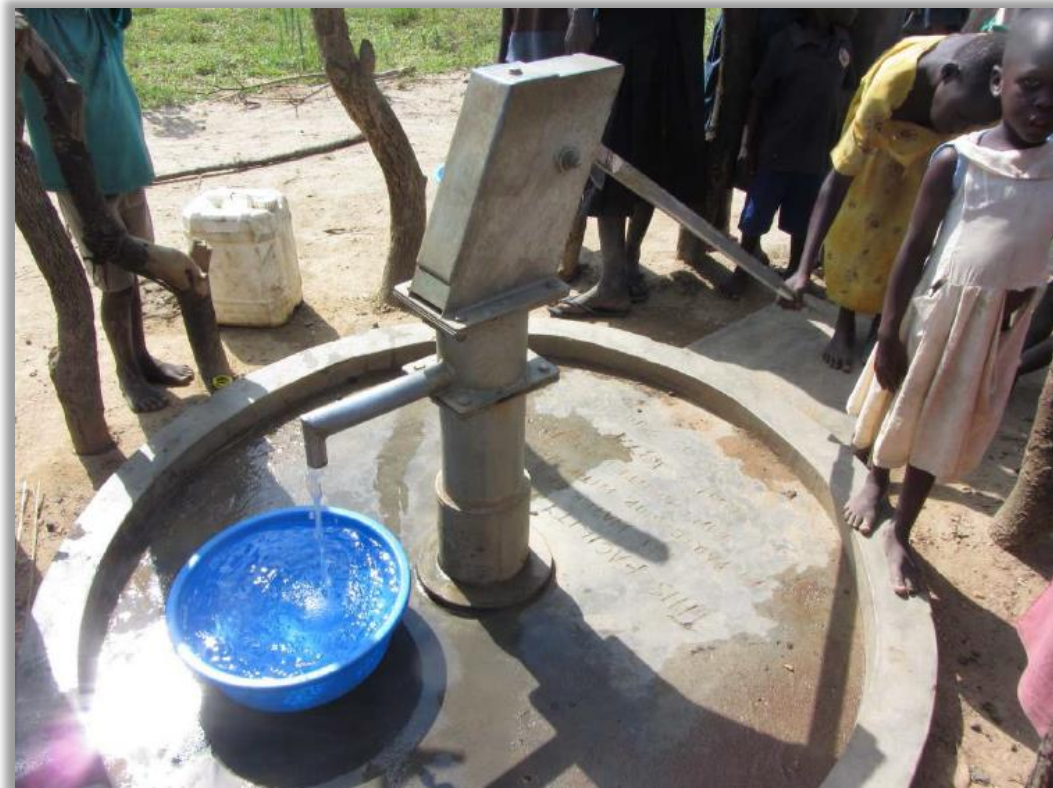
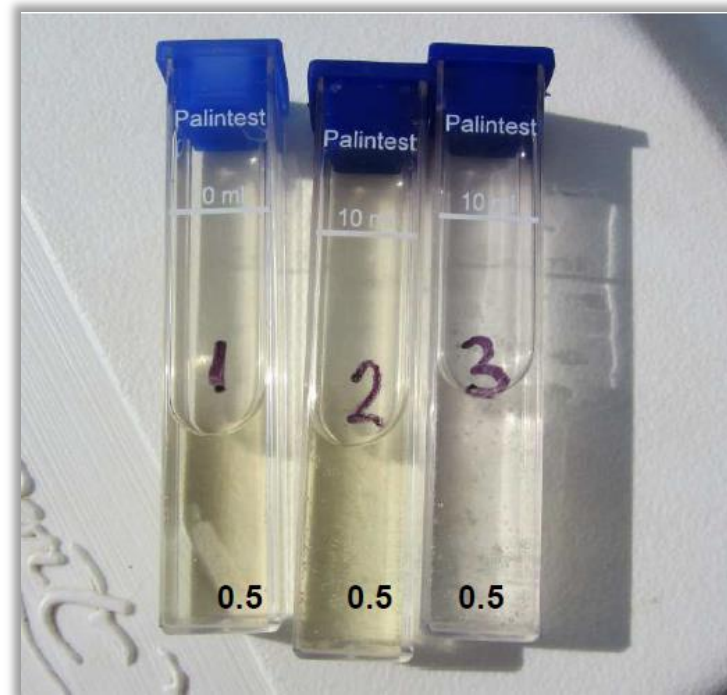
Abwanget – U3M Pump
pH= 5.96 – 6.00 Aggressive!!
No change in iron concentration
during pumping test – likely
natural level at 0.5 mg/L
