# HIT THE GROUND RUNNING TROUBLESHOOTING WITHIN A RECENTLY MODIFIED AMINE UNIT

*Laurance Reid Gas Conditioning Conference  
February 17-20, 2026 – Norman, Oklahoma USA*

Matthew Cunningham  
Williams  
One Williams Center  
Tulsa, OK 74103  
matthew.cunningham@williams.com

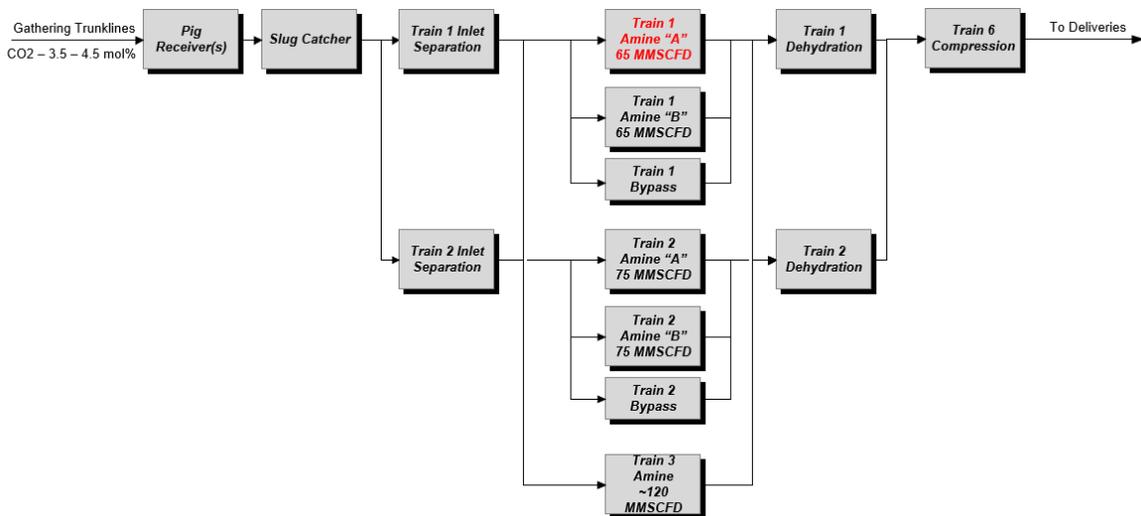
*Figure 1 – Facility Block Flow Diagram*

The North Desoto Treatment Facility in the Louisiana Haynesville shale has three inlet gas treating trains with a combined operating capacity of 650 MMSCFD of amine treating as depicted in Figure 1. The inlet gas treaters at this plant treat lean gas from domestic Haynesville shale wells by removing CO<sub>2</sub> content to reach pipeline specification. Amine treaters in Train 1 and Train 2 feature individual treater trains, “A” and “B”, each with an independent contactor and still set. Each treater “A” and “B” features a gas bypass to blend inlet gas with treated gas downstream. There are two total inlet separation trains upstream of treating and two total trains of TEG dehydration on the outlet of the amine treating trains prior to compression.

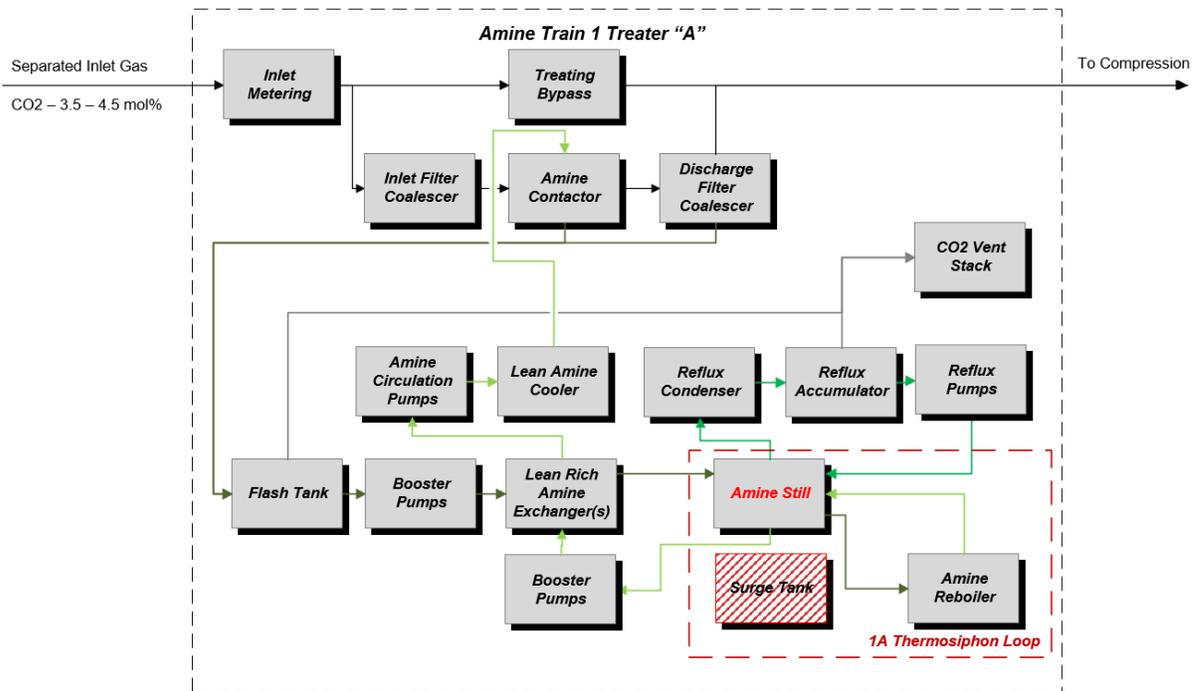
Figure 2 – Amine Train 1 “A” Block Flow Diagram

This paper focuses on the challenges faced when working to mitigate existing mechanical issues while commissioning a new Amine Still after recently introducing a new solvent for increased capacity in Amine Treater 1A. Treater 1A has an installed nameplate capacity of 65 MMSCFD, at 350 GPM circulation rate of amine. Each Amine Train features 1 stage of inlet filtration followed by an amine contactor, 1 stage of post contactor filter separation, and then TEG dehydration. Excess gas above 130 MMSCFD for the treating train (1A and 1B combined) is bypassed to blend out with treated gas to meet required outlet pipeline CO<sub>2</sub> specification. The solvent is a proprietary alkanolamine, which contacts the inlet gas stream that has a varying CO<sub>2</sub> composition of 3.5-4.5%. This plant serves to remove acid gas content to meet pipeline tariff prior to compression into the sales gas pipelines. Amine Treater 1A's amine regeneration system features a flash tank, lean / rich exchanger, still, horizontal reboiler, reflux condenser, reflux accumulator, and CO<sub>2</sub> vent stack. Refer to the block flow diagram in Figure 2 below.

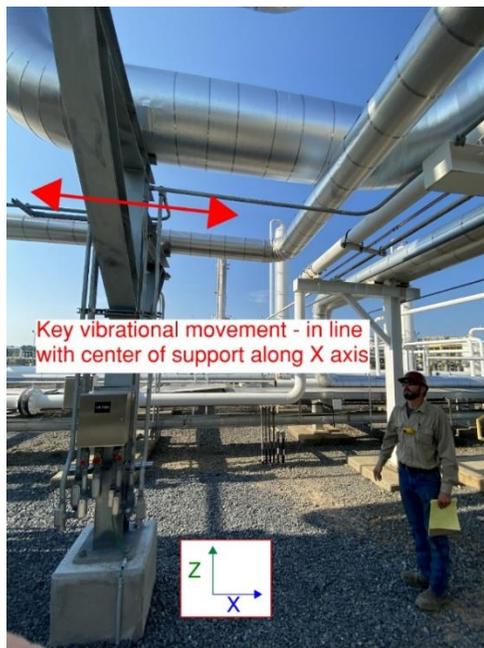
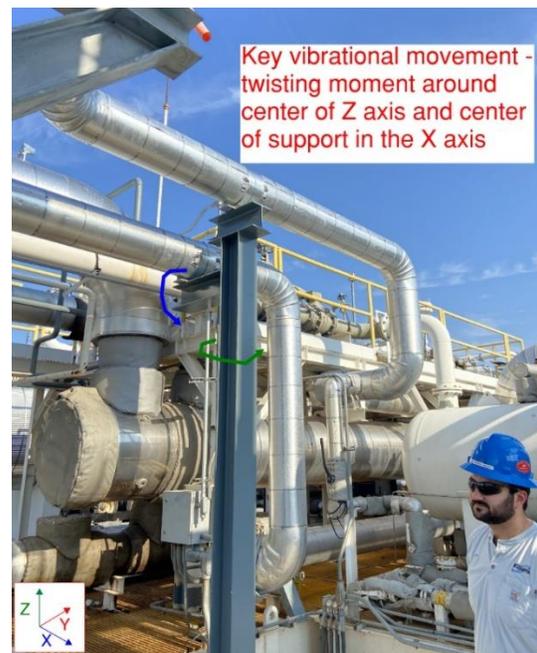
*Figures 3 & 4 – Reboiler Piping Vibration in the ZX Plane, Liquid Draw Piping Vibration around the X & Z axis.*

As commissioning commenced, the reboiler skid and associated piping to/from the Amine Still experienced visible and concerning vibration, which appeared to be the result of liquid slugging in the liquid draw line to the reboiler and in the 2-phase return line from the reboiler to the Amine Still. Movement was visually prominent and confirmed with a high-speed vibrational amplification camera as shown in Figure 4 below. The 24" main reboiler return piping and the 8" reboiler liquid draw line were both demonstrating a movement that exceeded operations comfort level led to the shutdown of the unit. This triggered further evaluation of the process and support design for the thermosiphon loop. After shutdown of the unit, the original 3rd party engineering design firm was consulted and suggested an additional support, which was installed on the 8" liquid draw line shown in Figure 4. Unfortunately, this support installation did not improve the vibration issues within the system, and the new project team was left to find a solution to overcome the issues encountered in a project largely completed by others before them.

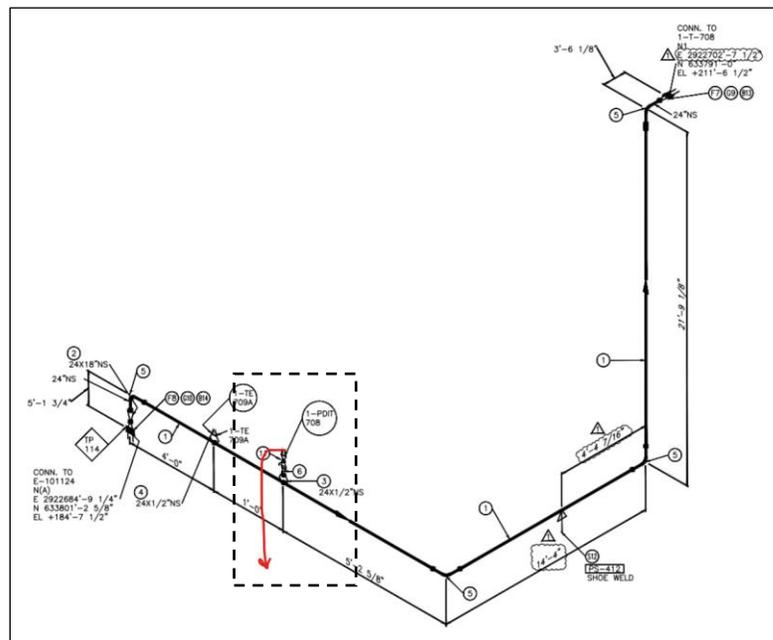
**Figure 5** – Isometric of Liquid Draw Line and Sample Point for 2 Phase Flow Verification

After the initial installation of the new Amine Still and Surge Tank removal, process issues were discovered in the liquid draw line to the horizontal reboiler. It was observed that 2-phase flow was occurring in the reboiler draw nozzle. 2-phase flow was verified by venting off an existing transmitter port upstream of the reboiler entry point as identified on the piping isometric in Figure 5. Intermittent vapor built up on a 10-20 second cycle and would vent as steam through the tubing line to the containment of the skid below the tubing. This process was repeated on 2 other startup attempts in the first 3 weeks of the unit being placed back into service.

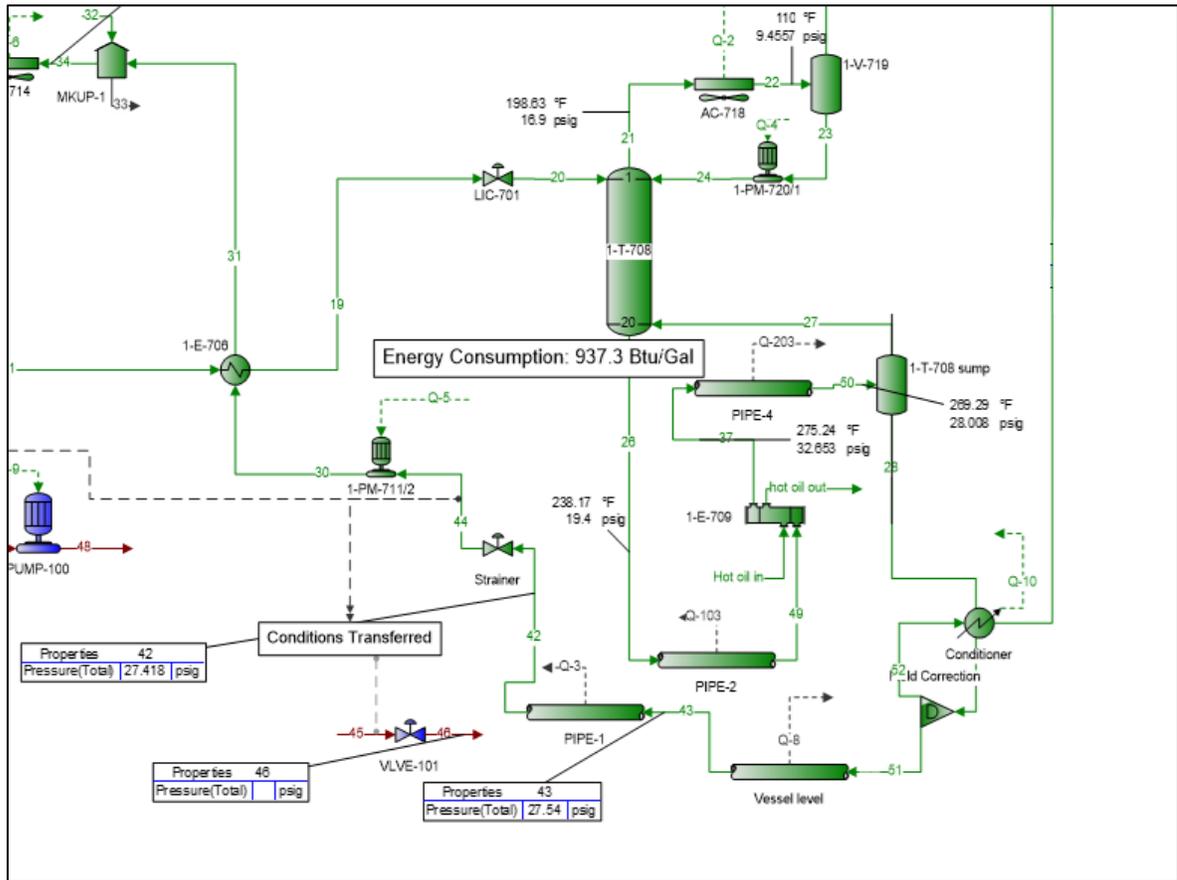
**Figure 6 – Process Model Snapshot for Thermosiphon Hydraulic Flashing Check**

To evaluate this scope in more detail, the project team leveraged process simulation via BR&E's Promax software via interaction with the solvent vendor. This approach led to modeling the piping

runs to get a better understanding of whether the piping hydraulic (pressure) losses were a root cause of flashing within the line, leading to pressure buildup into the reboiler. Figure 6 shows the use of the “pipe” process tools being used to validate the pressure drop of the reboiler liquid draw piping. Analysis of this piping with process data and real-world piping configuration (line size, pipe schedule, actual lengths, heights and fittings) was used to validate that under the operating case that there was not a concern of flashing in either line. Supply pressure at the reboiler inlet nozzle was validated to meet the required pressure after piping losses were accounted for. The next step considered was vapor entrainment in the liquid draw nozzle to the reboiler.

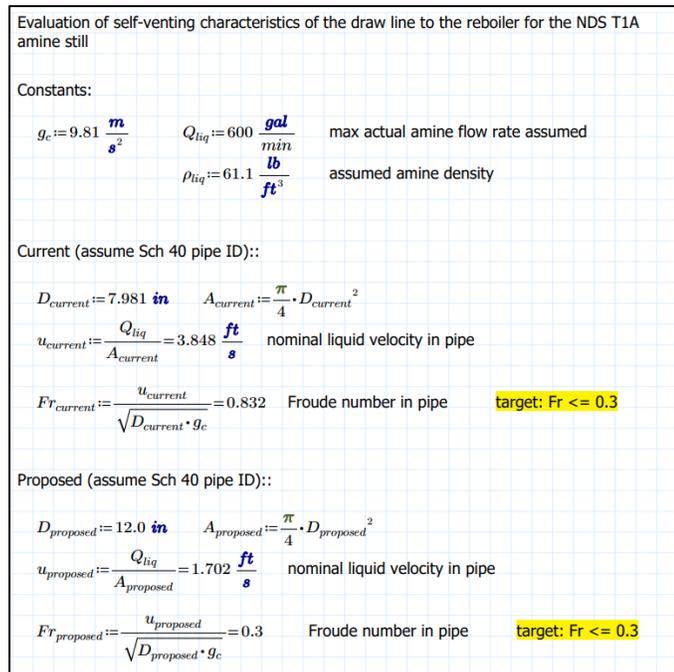
Figure 7 – Self Venting Flow Internal Calculation for Backcheck

To validate vapor entrainment concerns in the liquid draw line to the reboiler, a separate 3<sup>rd</sup> party process engineering firm was contracted to complete an evaluation in addition to an internal check of the self-venting flow sizing of the liquid draw nozzle and tray internals of the Amine Still. 3<sup>rd</sup> party engineering firm guidance laid out a target Froude number <0.3 to maintain self-venting flow. The Froude number for this nozzle was determined to be between 0.18 at full turndown, 0.72 at design, and 0.81 at turn-up conditions. These calculations suggest that the piping is not sized for self-venting flow, and that vapor is being entrained in the liquid at the high velocities exiting the tower. This calculation is demonstrated in Figure 8 and Figure 9 below shows calculation of the Froude number of the draw line to the reboiler.

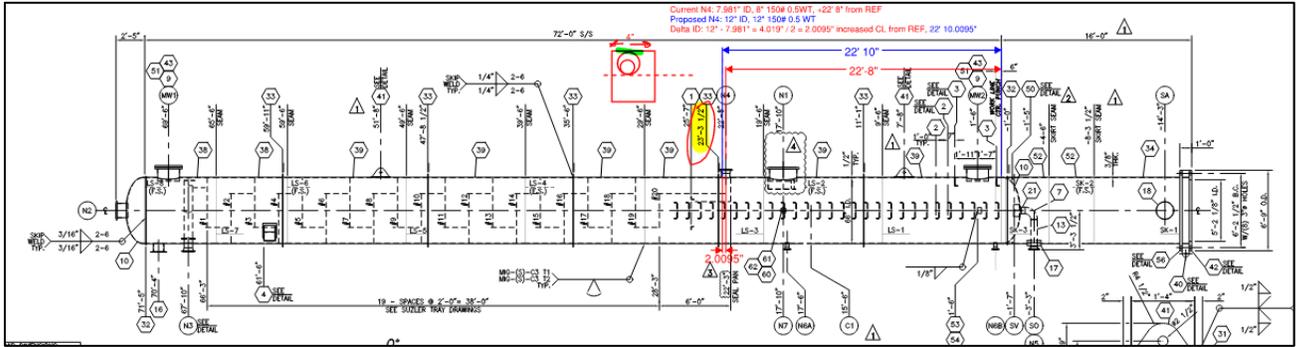
**Figure 9 – 12" Nozzle Location to Maintain Bottom of Opening Elevation**

To mitigate the existing 2-phase flow issues identified by this analysis and by field witnessing, an in-field Amine Still liquid draw nozzle modification, vessel internals change, and piping upsize to the reboiler was completed. The vessel nozzle size was increased on the Amine Still to a diameter of 12" versus the existing 8" nozzle supplied with the vessel. The field modification of the Amine Still required the cutout of the old nozzle, hydrogen bakeout heat pre-treatment prior to welding the new nozzle in, field welding of the new nozzle in via an ASME R2 stamp certification of repair, and post-weld heat treat of the heat affected zone of the nozzle weld area. The new nozzle was located with the same bottom of inner diameter elevation (nozzle growing upwards) to retain the same tray location per Figure 10.

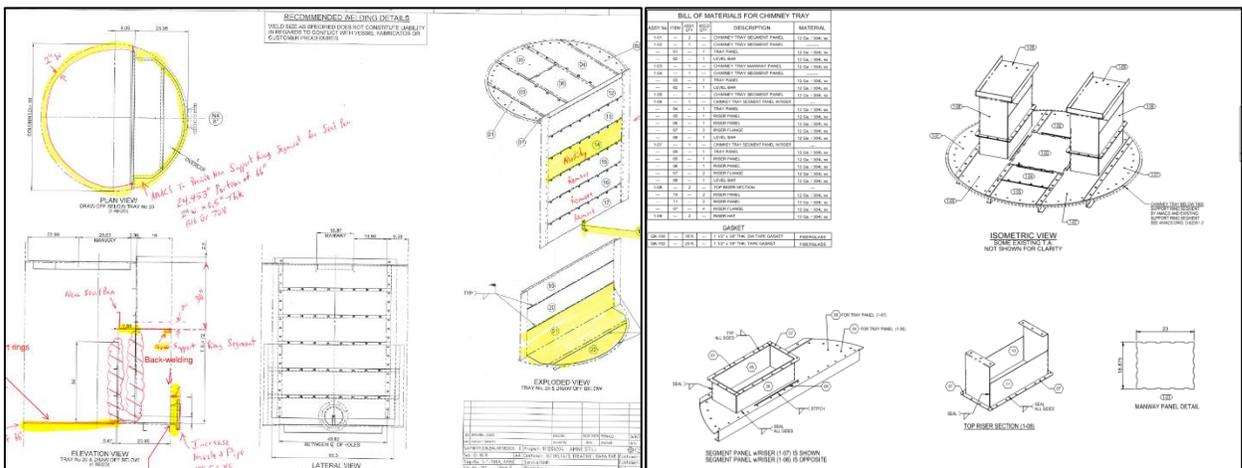
**Figure 10 – Existing Downcomer Seal Pan Tray and Support Ring Modifications**

Amine Booster Pump hydraulics experienced considerable benefits due to the Amine Surge Vessel being relocated to an integral surge with the new Amine Still, resulting in a higher liquid level / head available to the booster pumps. The Amine Booster Pumps liquid head increase reduced the cavitation / flashing in the booster pump suction piping previously experienced. After the initial piping support recommendation was installed and observed to not have reduced the impact of the vibration, the process engineering firm evaluating the Amine Still nozzles above also reviewed the tower internals and discovered that the original Amine Still chimney tray design had not been replicated as a part of the replacement Amine Still. This triggered design of a new chimney tray and downcomer seal pan to replace the liquid downcomer seal pan currently supplying flow to the liquid draw line of the amine reboiler. Process review of this design revealed an approximately 300% increase in resonance time with the addition of the chimney tray design shown in Figure 11. Special consideration was kept maintaining the same tray elevation in the Amine Still by expanding the existing downcomer seal pan support ring around the vessel. Modifications to the existing downcomer were completed per the redlines in Figure 10. The tray was maintained, but the downcomer sections were reduced to meet a new elevation above the proposed chimney tray.

**Figure 11 – New Chimney Tray Design**

After completing the tray internals modifications, Amine Still nozzle upsize, piping upsize, and re-inventorying the Amine Still, another startup was attempted. Vibration was reduced by approximately 40% but still fell outside of acceptable levels. 2-phase flow was then checked again during startup in the liquid draw line, and no steam/cyclical pressure buildup was observed in the line. The process modifications were successful in mitigating the process issues, and the larger focus then became constraining the reboiler outlet piping, which was now the main driver of vibration in the piping system.

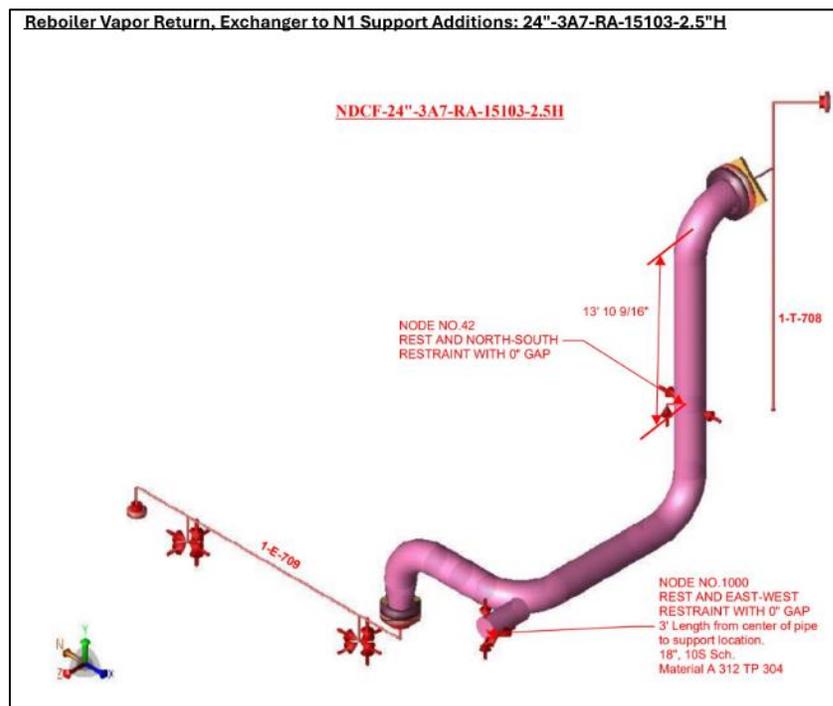
**Figure 12** – Support Mitigation Locations on 24” Reboiler 2-Phase Return Line

Vibration / pulsation readings were taken via a high-speed camera for 3 locations on the 24” reboiler return piping to the Amine Still. These readings depicted a system that was still unconstrained and dealing with slugging in the 2-phase return line from the reboiler back to the Amine Still due to directional changes in the horizontal and vertical elbows. This, combined with the new Amine Still location and support methodology, effectively left horizontal forces unaccounted for, and only supported the vertical loads. New pipe stress analysis was completed the 3<sup>rd</sup> party engineering firm supporting the thermosiphon loop analysis and as a result proposed two additional support mitigations as depicted in Figure 13. These support mitigations were installed on the 24” reboiler return piping to resolve pulsation issues due to the increased length of piping and unaccounted for 2-phase slugging support for the vessel piping mentioned above.

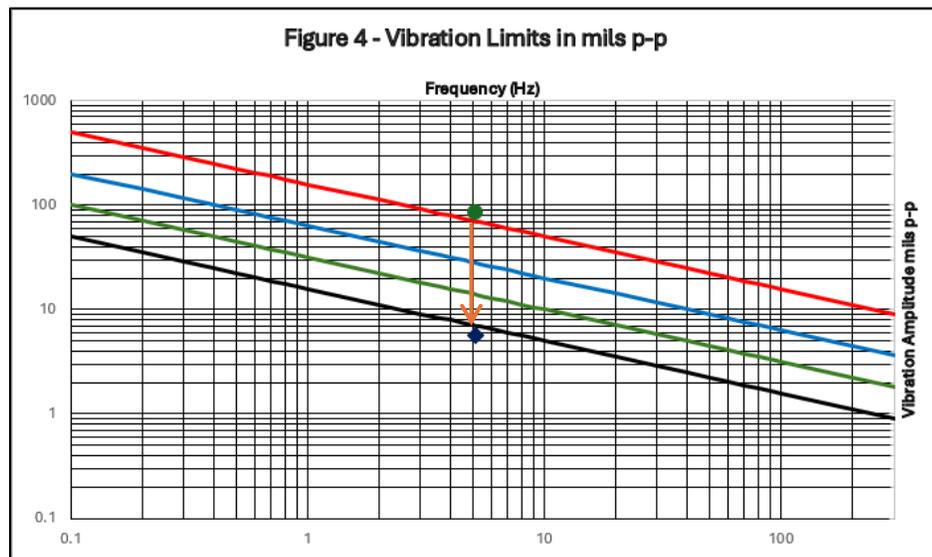
*Figure 13 – Vibration Limits Observed in Reboiler Return Piping*

Plotted below in Figure 13 are the observed vibration points on the reboiler return pipe, both pre- and post-support installation. Point 1 (circle) above the top line is the starting point of vibration observed, while the second point that the arrow points to (diamond) is below the action required line for Y-axis vibration measured in amplitude (mils peak-to-peak). The vibrational limitation is

based on Williams internal standards within Williams Integrated Management System (WIMS). The X-axis in Figure 14 is the frequency represented in hertz (hz). Field documented vibrational data in the X, Y, and Z axis on the reboiler and its associated return piping was crucial input into support mitigation design. Stress analysis for the thermosiphon loop took careful evaluation of constraints via thermal growth of the reboiler and the return piping to the Amine Still to not exceed the nozzle loadings of either vessel.

After installation and subsequent startup of Train 1A with the modifications, the process and mechanical issues experienced as a part of the initial commissioning effort for the new Amine Still were resolved. 2 phase flow was not documented in the reboiler liquid draw line, demonstrating the effectiveness of the newly installed tower internals paired with the upsized liquid draw nozzle ensuring self-venting flow was achievable. Vibration was reduced to within acceptable limits with the newly installed supports, reducing loading on the vessel nozzles and allowing for thermal expansion while constraining potential 2 phase slugging experienced in the return line from the Reboiler to the Amine Still.

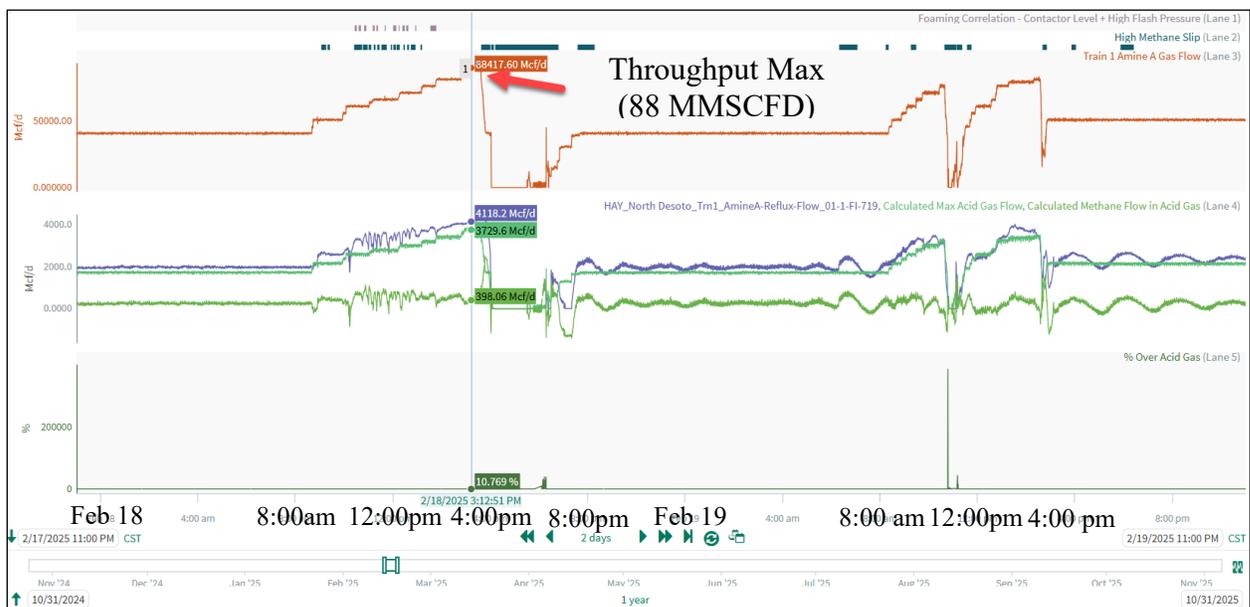
**Figure 14 – Operating Data Showing Highest Nameplate without CO2 Slip on Day 1**

The trend information on Figure 14 is as follows: Section 1; Amine 1A Inlet Gas Flow. Section 2; Amine Reflux / Acid Gas Flow, (FI-719), Calculated Max Acid Gas Flow (discussed in the sections following this), and Calculated Methane Flow in Acid Gas (Net difference in Reflux / Acid Gas Flow vs Calculated Max Acid Gas Flow). Section 3; % Over Acid Gas (categorized as Calculated Methane Flow over Calculated Max Acid Gas Flow).

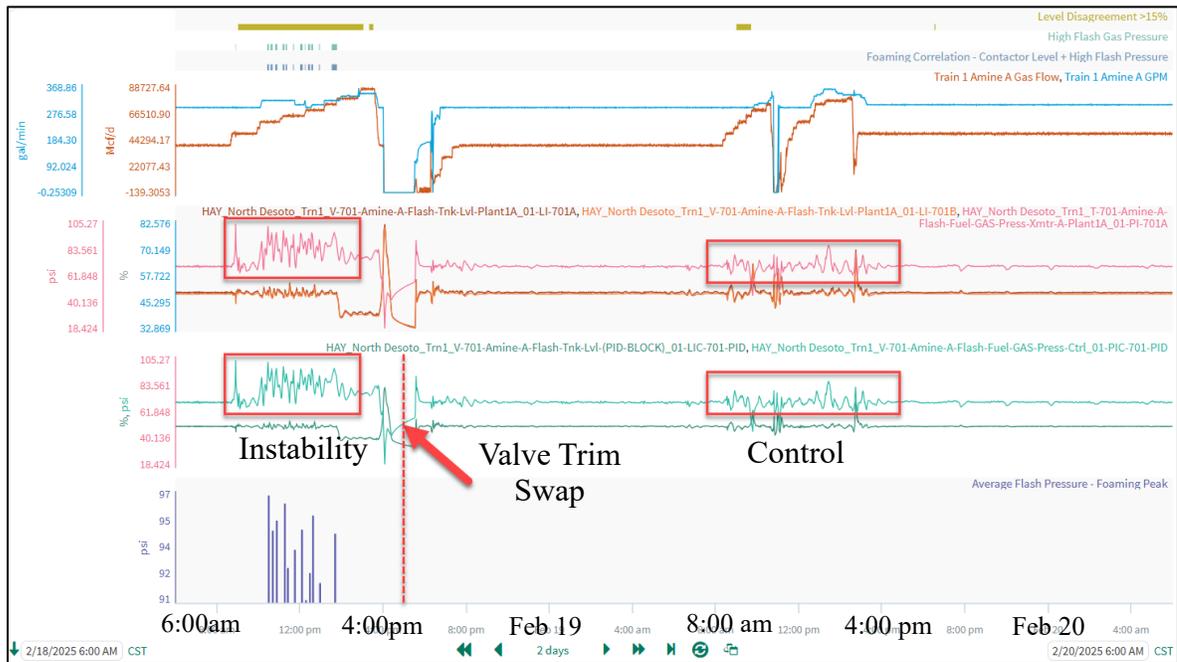
**Figure 15** – Operating Data Showing Erratic Flash Tank Pressure Behavior via PI-701A on Day 1, and Calm System after Valve Trim Swap on Day 2

During performance testing on Day 1, the Flash Tank was observed to be at increased pressure and struggling to control with the pressure control valve PID loop PIC-701 (depicted on the upper trend line of the third lane in Figure 15 below). The operations team changed out the valve trim for flash gas control valve to see if increased capacity would help smooth out flash gas cycles demonstrated in Figure 15. The change was successful as the valve came into the control range and ceased

behaving erratically on the PID loop, while the peak flash tank pressure was no longer observed to exceed 90 PSIG on Day 2 of performance testing, as shown on trend section 4 of Figure 20.

The trend information on Figure 15 (above) is as follows: Top Time Segments; Level Disagreement >15% (Trend of Contactor Level Disagreement >15%), High Flash Gas Pressure (Pressure > 90 PSIG), Foaming Correlation (Intersection of Contactor Level Disagreement and High Flash Gas Pressure). Section 1; Train 1 Amine A Gas Flow, Train 1 Amine A GPM. Section 2; Flash Tank Level (LI-701A), Flash Tank Level (LI-701B), Flash Gas Pressure (PI-701A). Section 3; Flash Gas Level Controller PID (LIC-701), Flash Gas Pressure Controller PID (PIC-701). Section 4; Average Flash Pressure – Foaming Peak (Average Pressure during Foaming Correlation Time Capsules).

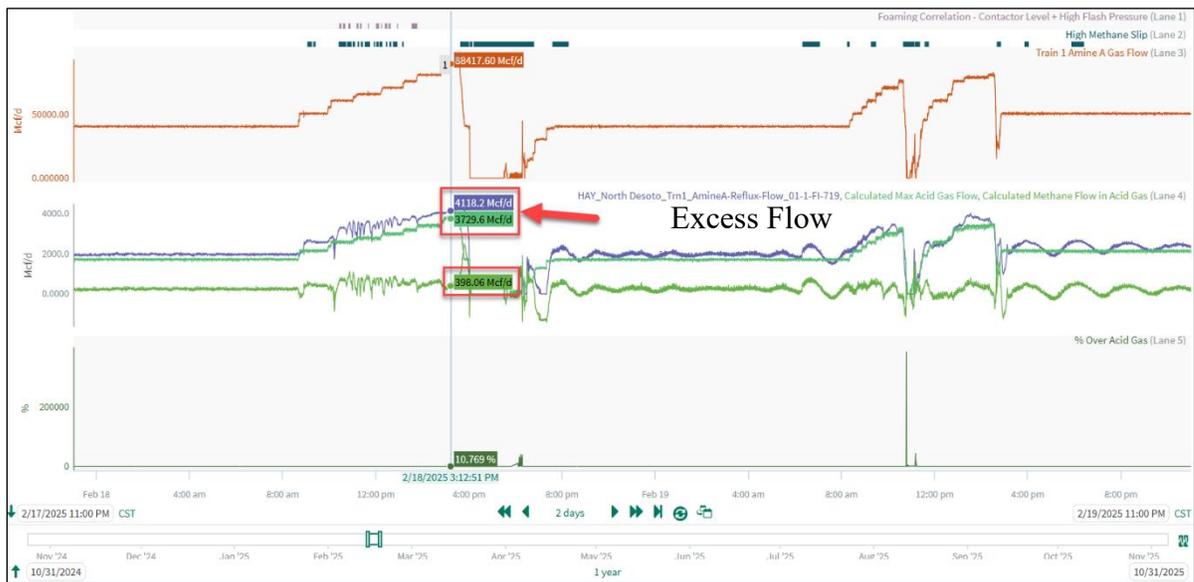
Figure 17 – Operating Data Showing Flow and Combined Reflux Acid Gas Flow with Calculated Excess Flow

Due to the original unit configuration, flash gas is comingled with the acid gas from the amine still prior to FIT-719 and sent to the CO2 scrubber. An additional calculated analysis was performed on the acid gas flow meter (FIT-719) to the CO2 vent stack of the unit to demonstrate if excess flash gas flow to the CO2 vent stack was exceeding the calculated flash from the process model and also exceeding the physical acid gas content of the inlet gas stream to the contactor shown in Figure 16 compared to the process data from the process model for the anticipated acid gas flow to the vent stack. This data is on a wet basis in the process model. Using the facility CO2 and H2S dedicated analyzers at the inlet of the plant and the inlet flow meter to the amine contactor T-432, a reasonable assumption was made that any acid gas flow through the acid gas meter exceeding the CO2 and H2S content in the wet inlet gas stream to the contactor could be assumed to be hydrocarbon slip due to foaming making its way into the amine flash tank and flashing off into the acid gas vent stream, as shown in Figure 16. Additional analysis is recommended for engineers pursuing this approach in the future.

The trend information on Figure 17 is as follows: Top Time Segments; High Methane Slip (categorized as Calculated Methane Flow exceeding 20% of Calculated Max Acid Gas Flow). Section 1; Amine 1A Inlet Gas Flow. Section 2; Amine Reflux / Acid Gas Flow, (FI-719), Calculated Max Acid Gas Flow (discussed above), and Calculated Methane Flow in Acid Gas (Net difference in Reflux / Acid Gas Flow vs Calculated Max Acid Gas Flow). Section 3; Over Acid Gas (categorized as Calculated Methane Flow over Calculated Max Acid Gas Flow).

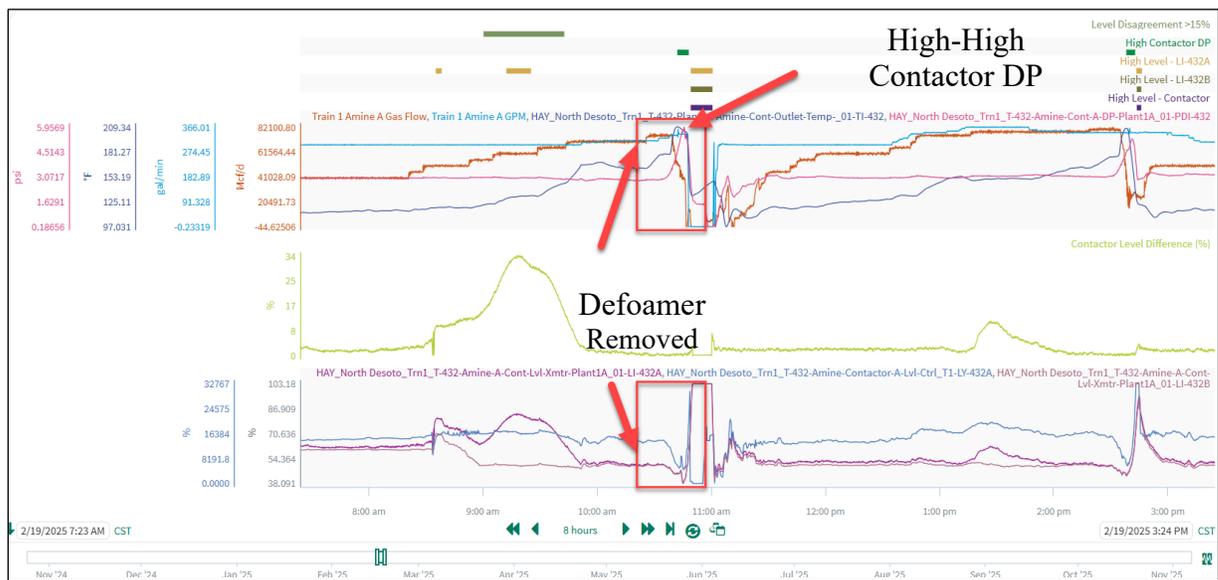
**Figure 18 – Operating Data Showing Gas Flow, Circulation Rate, Contactor Outlet Temperature, and Level Differences in the Contactor**

The initial hypothesis was that the cause of the issues above were due to foaming in the contactor. Data was trended to demonstrate level disagreement between LI-432A (guided wave) and LI-432B (magnetic level); this is shown on trend Sections 2 (% disagreement between each level device) and 3 (readings of level and contactor dump level control) on Figure 18.

The trend information on Figure 19 is as follows: Top Time Segments; Level Disagreement >15% (Trend of Contactor Level Disagreement >15%), High Contactor DP (Differential Pressure > 4.5 PSID), High Level – LI-432A (Level in LI-432A > 80%), High Level – LI-432B (Level in LI-432B > 80%), High Level – Contactor (Intersection of both High Levels). Section 1; Train 1 Amine A Gas Flow, Train 1 Amine A GPM, Contactor Outlet Temperature (TI-432), Contactor Differential Pressure (PDI-432). Section 2; Contactor Level Difference % (net difference in level %). Section 3; Contactor Level Transmitter (LI-432A), Contactor Level Controller % (LY-432A), Contactor Level Transmitter (LI-432B).

The next day of testing, the operations team elected to inject defoamer into the system during performance testing, trying to resolve the apparent foaming / level issues demonstrated in the contactor the day prior. As a test to this theory, defoamer injection was removed at approximately 10:21AM at 75 MMSCFD of gas throughput. Following this defoamer removal, the gas contactor began to behave erratically as shown in Figure 17, leading to carry-over into the downstream filtration and shutting down the unit on high tower DP.
